### 2022 Annual Inspection Report

for CCR Surface Impoundment

Plant Smith Ash Pond Southport, Florida

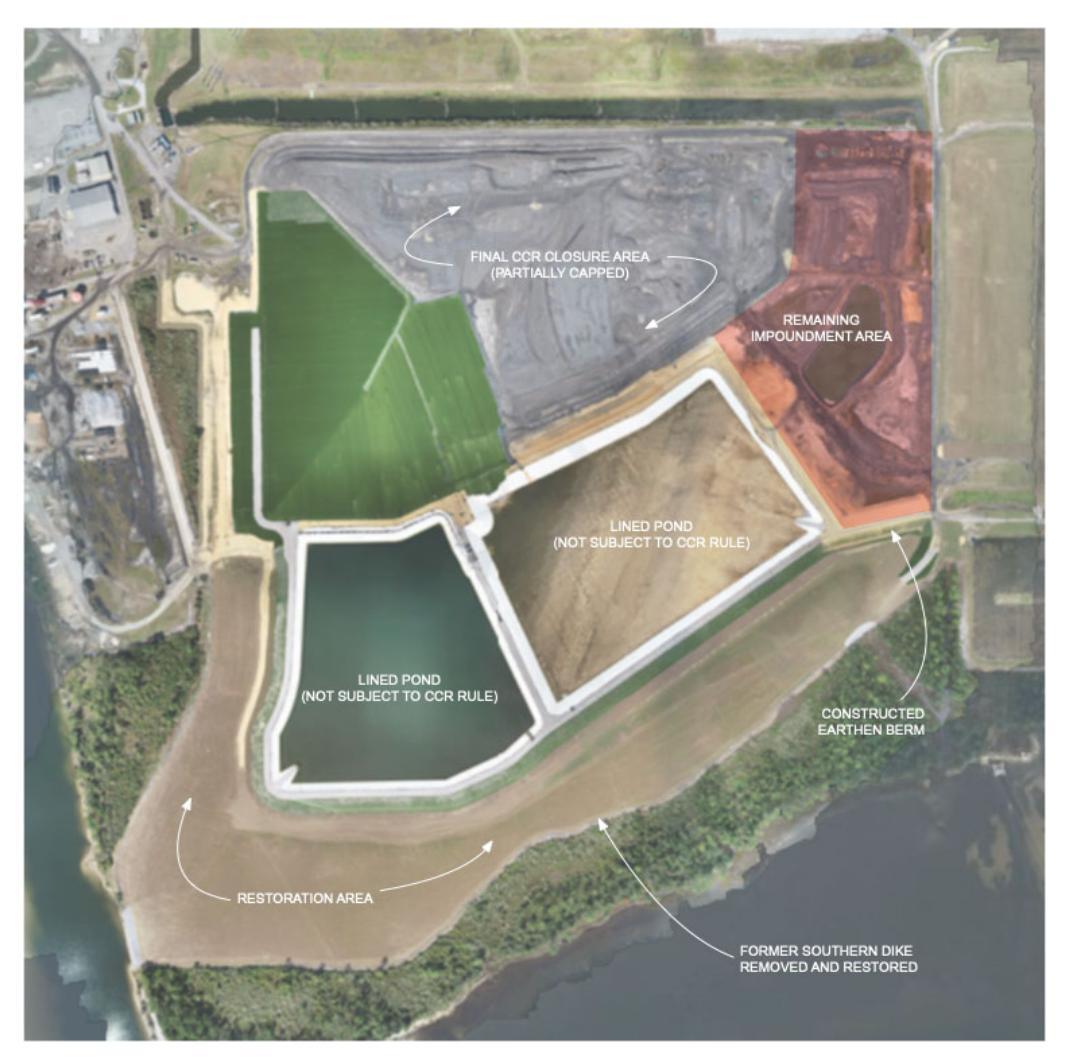
Figure 1: Aerial Image of Plant Smith Impoundment dated October 28, 2022

The remaining portion of the south dike has been removed as part of closure activities (See Figure 1). Calculated storage capacity values incorporate this change in geometry. In addition, the final closure area elevation has increased to 73 ft. mean sea level (MSL) due to closure construction. This elevation is anticipated to be the maximum elevation of the placed and compacted CCR.

The impoundment capacity of the Plant Smith impoundment at the time of the inspection is estimated to be approximately 180,000 cubic yards. Depths, elevations, and storage capacity are estimates derived by qualified personnel from available information and do not include the area above the original CCR elevation where CCR is being placed and compacted per the approved closure plan, e.g., the storage capacity does not include placed and compacted CCR. The volume is based on the area noted on Figure 1 as remaining impoundment area.

The site is currently undergoing closure construction that involves consolidating the CCR footprint to a smaller area. Construction completed since the last inspection has included complete removal of the southeastern and southern containment dikes and restoration of those areas with placement of clean fill and vegetation. Process water from plant operations is currently stored within a lined pond in the southwest area of the site where CCR was previously removed. This storage area is not subjected to the CCR rule. A permanent earthen dike has been constructed on the eastern side of the site for future management of plant wastewater and stormwater. This dike currently serves as containment of contact water and CCR stockpiles during ongoing construction. These features are noted in the facility aerial photograph in Figure 1.
