2022 Annual Inspection Report
for CCR Surface Impoundment

Gulf Clean Energy Center Gypsum Storage Area
Pensacola, Florida

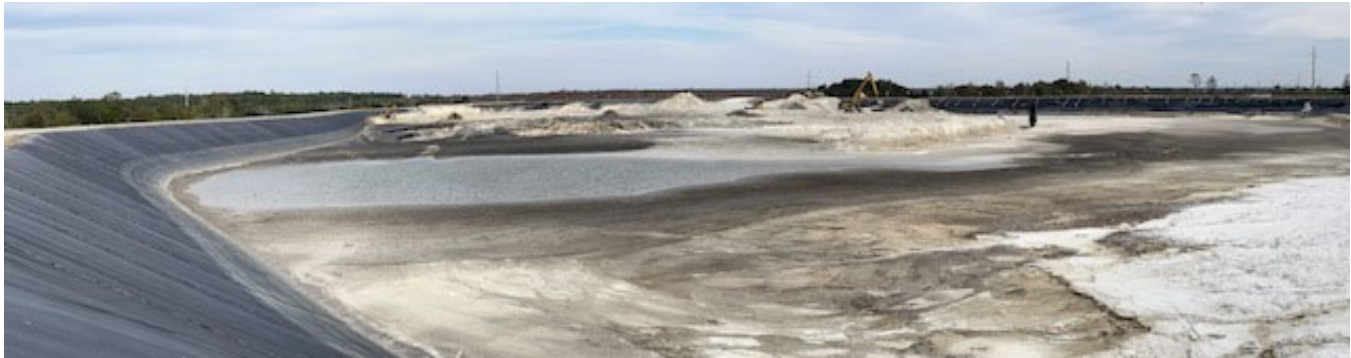
Since the past annual inspection, there were no observed changes in the geometry of the impounding structure.

Figure 1: Panorama Photograph at Time of Inspection – GCEC Gypsum Storage Area
